Vehicle History Report

Chassis number ¹: MNH10-0102600

Model: ALPHARD V

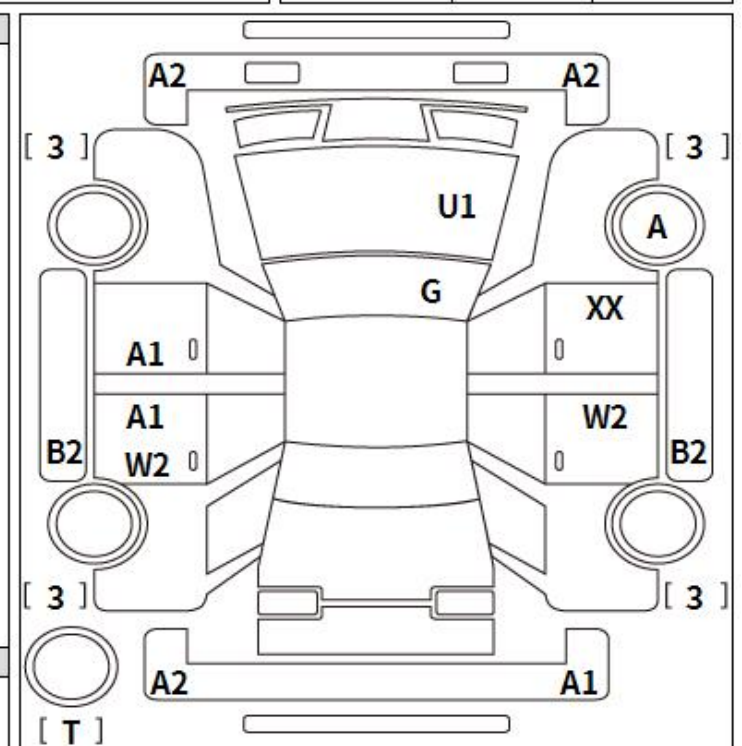
検査員記入欄
各部 S コンソール傷 ドア内張傷 天張薄汚れ バンパー下 A
事務局よりご案内
